MODAL INVESTIGATION OF AN OFFICE BUILDING FLOOR

R. Cantieni, S. Pietrzko

EMPA, Swiss Federal Laboratories for Materials Testing and Research
Ueberlandstrasse 129, CH-8600 Duebendorf, Switzerland

Procedures and results of an experimental and analytical Modal investigation performed on an 8.6 x 25.8 m office building floor are presented. This floor is part of a lightweight steel construction added inside of an existing 8 m high large steel frame building at an intermediate level of roughly 4 m. Complaints of people working in the new office of unacceptable floor vibrations induced by other people walking from their desk to the copying or fax machine were the reason for this investigation.

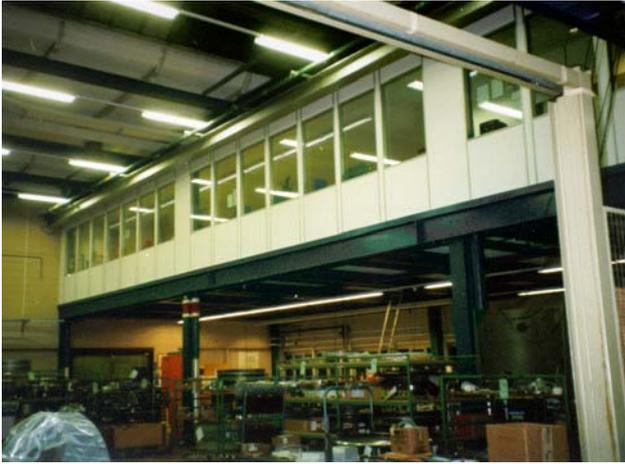
Fig. 2 View of the new office building "exterior wall" in axis K. To the far left the old wall in axis 13 can be seen, in the middle and to the right the two old columns in the axes 12 and 11.

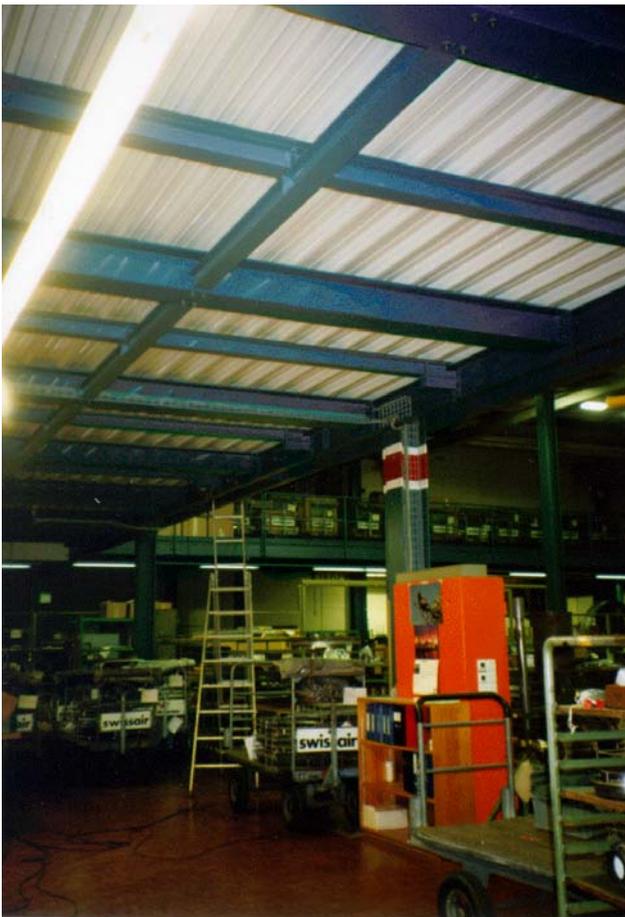
Fig. 3 View of the new steel floor underside. Cross beams from the left to the right, the corrugated steel sheet on top of them.

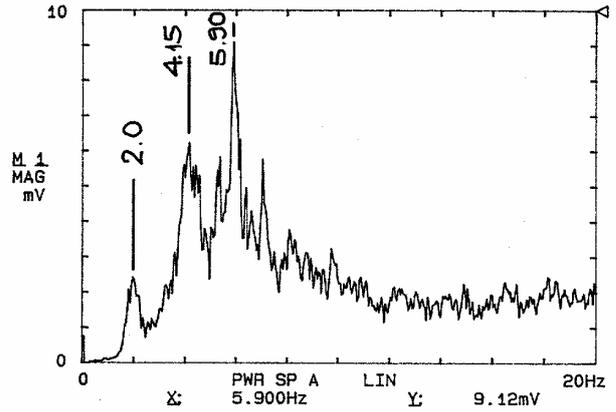
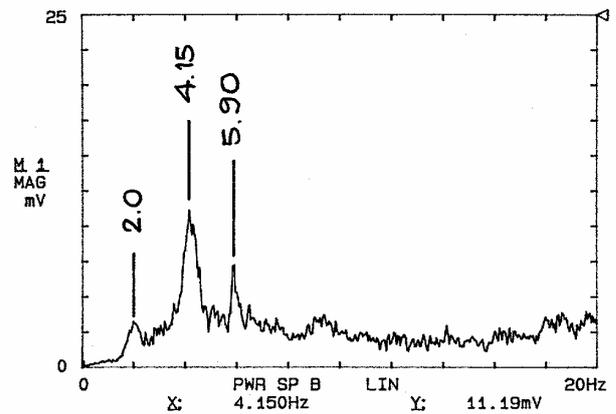
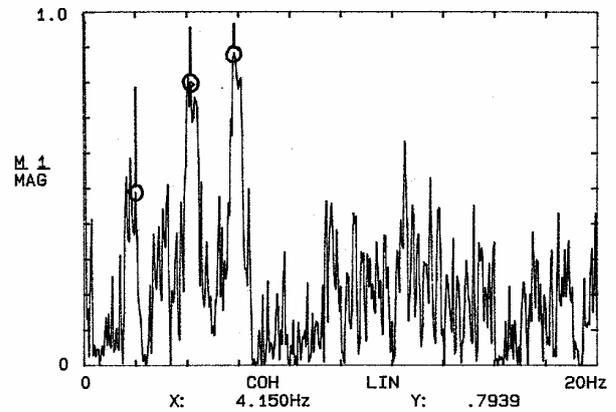
Fig. 4 Results of the preliminary tests: Top two figures: Frequency spectra as measured in the points A and B (see Fig. 1). The Coherence Function clearly shows a quite low value for the forced vibration at $f \approx 2$ Hz and higher values for the two floor natural vibrations.

- The maximum floor vertical acceleration amplitude was $a = 0.25 \dots 0.3 \text{ m/s}^2$, which is roughly ten times larger than usually rated as acceptable [1],
- The first two natural floor frequencies are $f_1 \approx 4.15 \text{ Hz}$ and $f_2 \approx 5.90 \text{ Hz}$.

This means that the floor was excited through the second and third harmonics of the forces produced by a walking person [2].

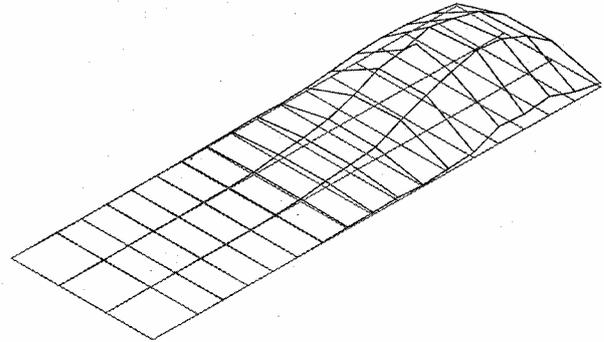
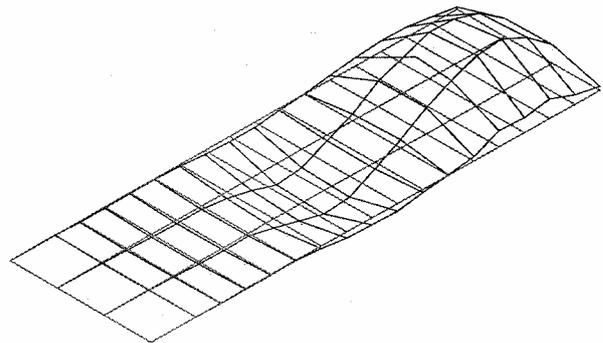
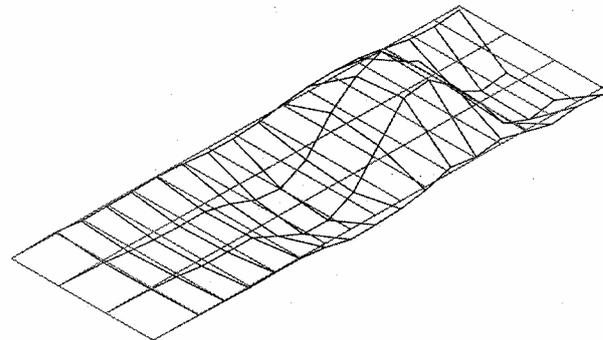
Fig. 9 Modes No. 1 to 3 as determined experimentally.

For all modes, the relative immobility of the floor in the area 10/11/K/L where interior walls exist is obvious. It becomes also clear from the mode shapes that the cross beam in axis 13 does not act as a stiff support but shows large relative movements.

$$f_1 = 4.29 \text{ Hz}, \zeta_1 = 2.76\%$$

$$f_2 = 4.83 \text{ Hz}, \zeta_2 = 2.74\%$$

$$f_3 = 5.83 \text{ Hz}, \zeta_3 = 3.41\%$$

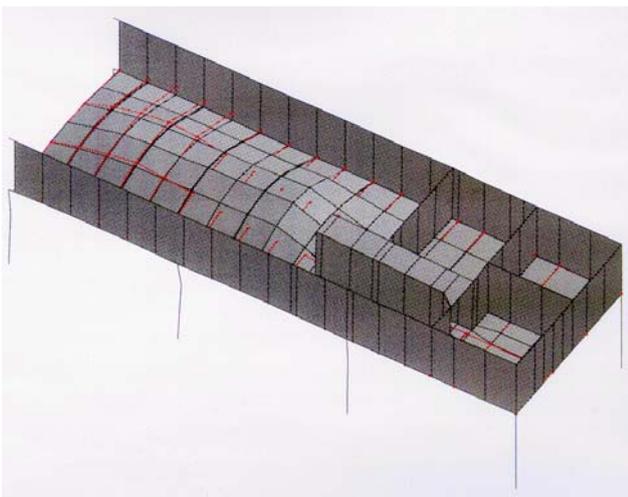
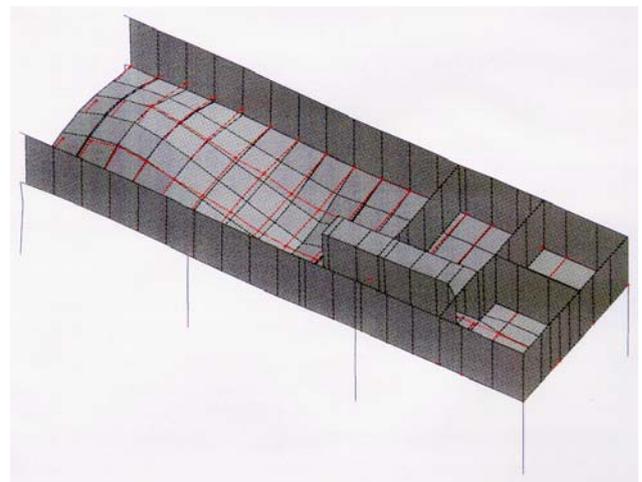
Mode 1, MAC = 81%

Mode 2, MAC = 77%

Fig. 12a Modes Nos. 1 and 2 as determined experimentally and analytically (axis 10 to the right).

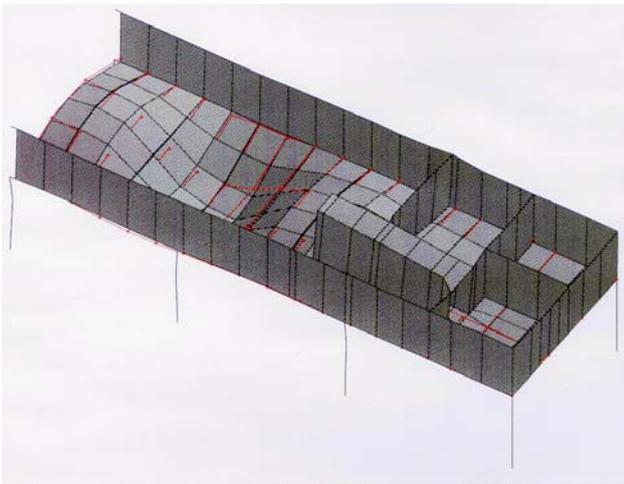
Mode 3, MAC = 79%

Fig. 12b Mode No.3 as determined experimentally and analytically.

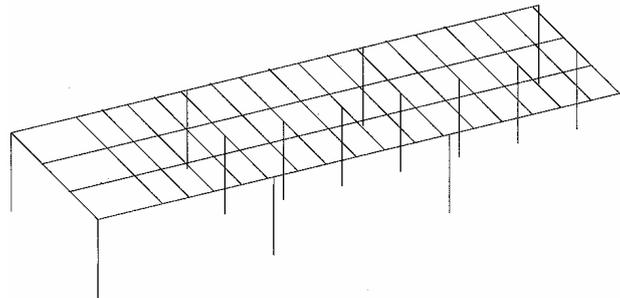
Fig. 14 Rehabilitation through adding of seven columns (compare with Fig. 10, but axis 10 now to the left).

Rehabilitation measure	Fundamental floor frequency f [Hz]
Addition of 7 intermediate columns (Fig. 14)	13.04
Addition of 6 intermediate columns; effectiveness depending on which one of the 7 columns is omitted	7.08...11.21
Addition of 4 intermediate columns; omitting every second of the 7 columns	7.09
Increasing the cross beam stiffness by a factor of 4	7.56
Addition of a stiff longitudinal beam plus three intermediate columns (axes 10, 11 and 12)	11.4
