Modal analysis of a river exploitation power house, with and without the turbine/generator units being in operation

ABSTRACT: The Eglisau River Exploitation Station has been built in the years 1905 to 1910. It is located on the Rhein River on the border between Switzerland and Germany and contains seven vertical axis Francis Turbine/Generator units. The power house is under protection as a historic monument. The owner of the power station, NOK, Nordostschweizerische Kraftwerke AG, plans to exchange the existing units through new Kaplan Turbine/Generator units. FE model calculations had shown that there might be a risk of ending up in structural vibrational problems when increasing the rotational frequency to $f = 1.85$ Hz from the actual $f = 1.39$ Hz. To allow validation of the respective model, experimental modal analyses using AVT, Ambient Vibration Testing, technology were performed. As a first attempt with the turbine/generator units being in operation failed, a second successful attempt was undertaken with the units being shut off. The paper discusses the reasons for the failure and success respectively.

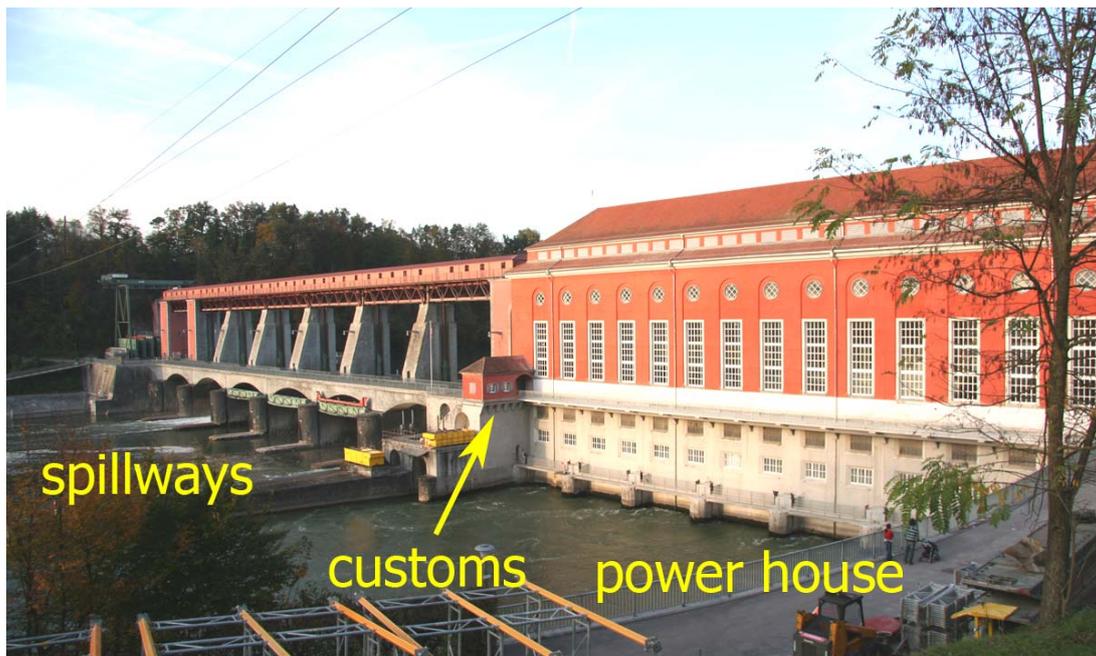
Figure 1 : The Eglisau Power Station from the downstream side. The old customs building is out of operation today.

The Eglisau power house is a reinforced concrete structure of about 90 m in length, 17 m in width and 45 m in total height (Fig. 1). It contains seven vertical axis Francis turbines and generators. Figure 2 gives a view into the machine house. We call the visible floor "machine floor" and the visible roof the "roof floor". What we can see on the machine floor are the covers of the seven generators. Underneath the machine floor, there is the so-called "turbine floor" which the top of the turbines is fixed to. The turbines themselves are located below the turbine floor where the power house is founded in rock (Fig. 3).

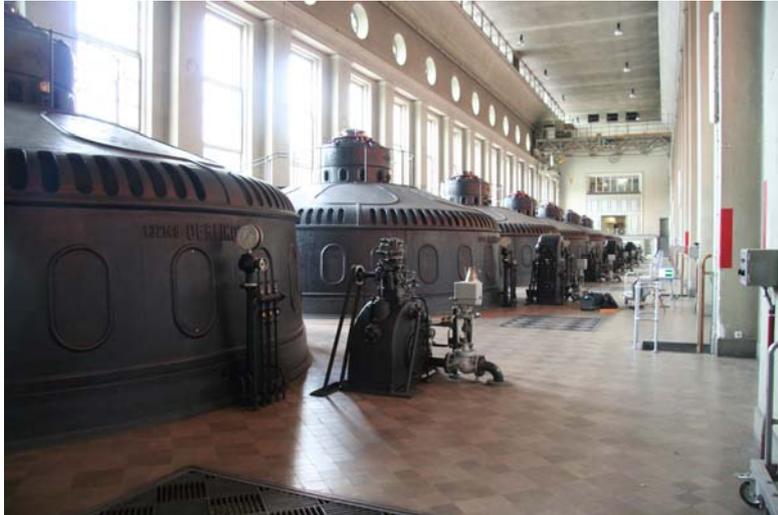
Figure 2 : View on the power house machine floor.

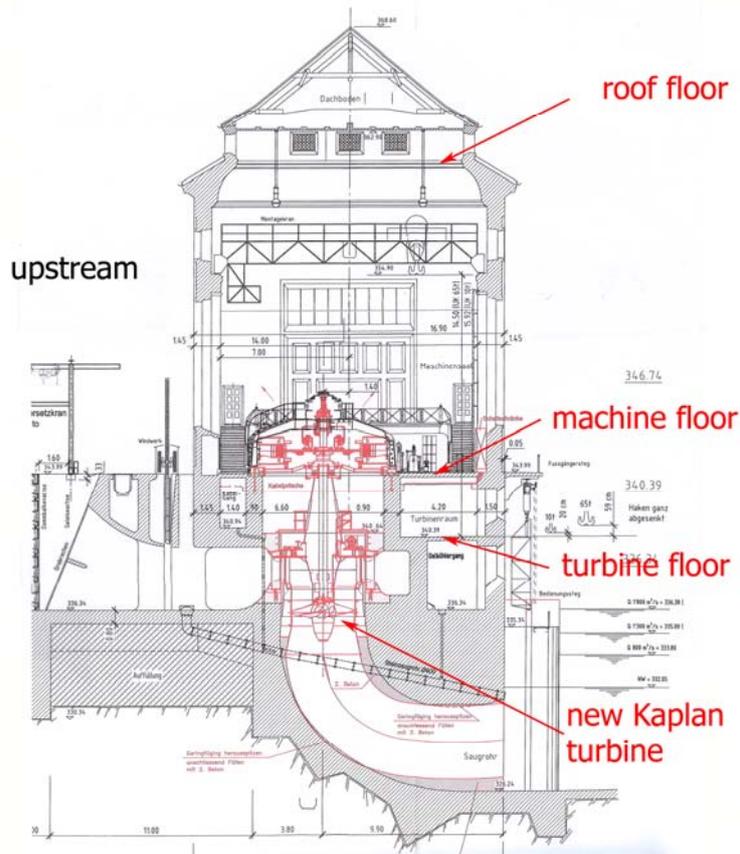
Figure 3 : Eglisau power house cross section (schematic).

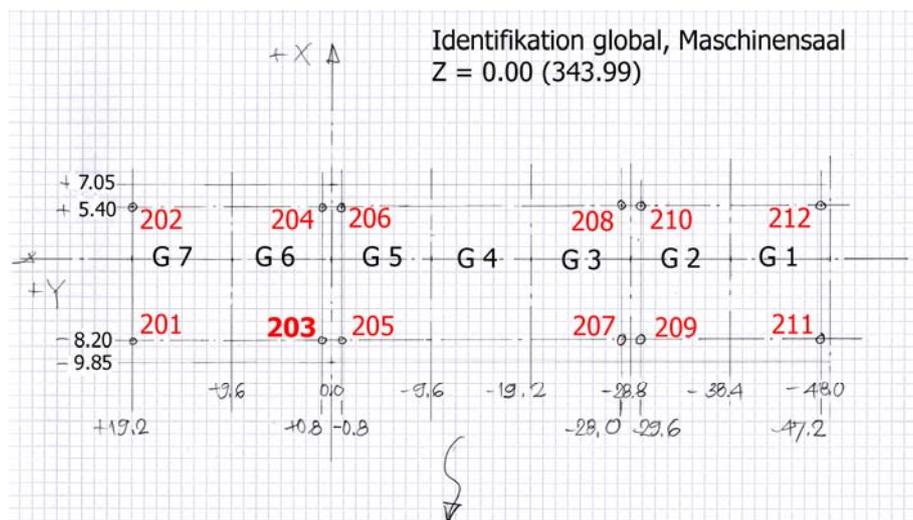
Figure 4 shows a plan view of the instrumentation layout on the machine floor level. G1 to G7 indicate the position of the seven generators. It also shows the fact that there are two vertical joints from top to bottom dividing the power house into three parts: Between units G6 and G5 and between units G3 and G2. It was one of the basic goals of the investigation discussed here to identify the effect of these joints on the structural dynamic behavior of the power house. Therefore, a measurement section was located on both sides of these joints. The roof floor and turbine floor were instrumented in the same way as the machine floor.

Figure 4 : Plan view of the instrumentation on the machine floor level for the global test. 203 is the reference point. Dimensions: m.

The turbine/generator related rotational movement is present in all mode shapes. This applies however for the regions of G7/6 and G2/1 only (Fig. 4). It is open to speculations why the power house middle part does not really rotate with the units running. Anyway, the rotational

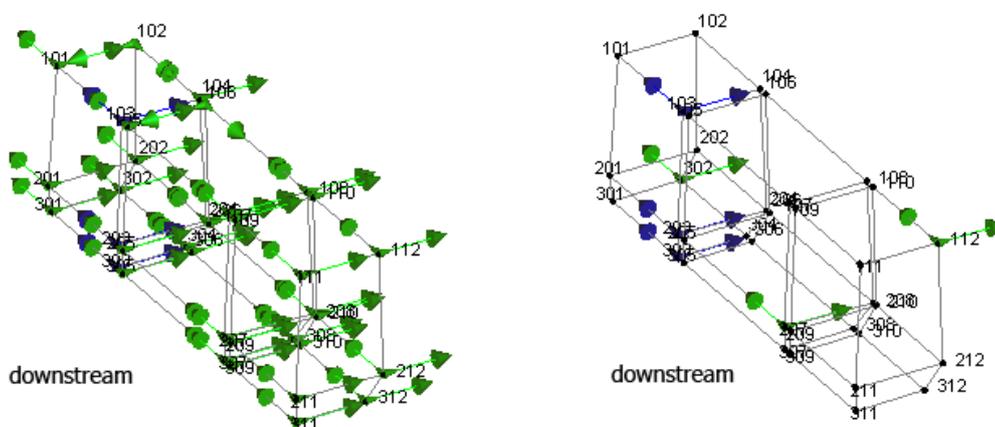
Figure 5: All measured degrees of freedom (left), and DOF's measured in setup 2 (right, references in blue). The levels "roof floor", "machine floor" and "turbine floor" can easily be identified. (The DOF's had to be adjusted to reality, the sensors not always having been installed in the planned horizontal directions.)

As can be seen from Figure 5, 12 DOF's were acquired in each setup with six DOF's being references and six being rovers. The number of reference DOF's seems to be quite generous but it was felt that the two horizontal directions should be referenced on all of the three measurement levels. Basically, there can hardly be too many references. The total of 66 roving DOF's was worked through with 11 setups.

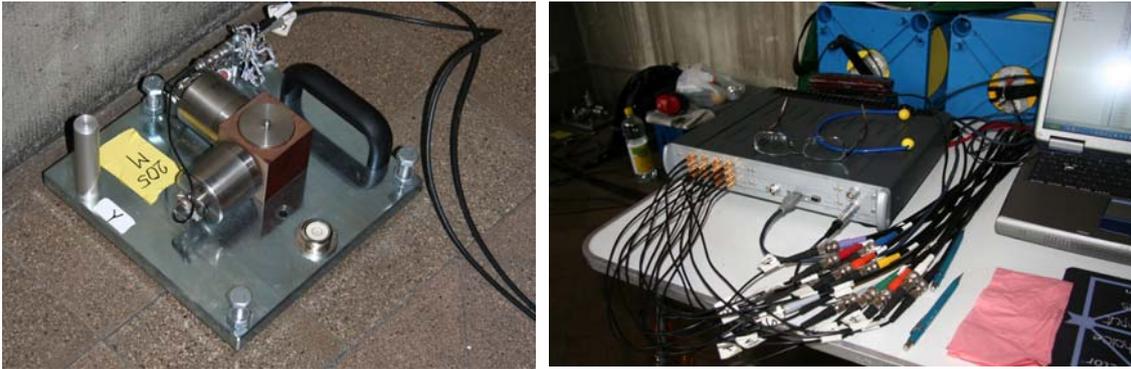
The accelerometers used were of the PCB 393B31 type (10 V/g sensitivity) and the data was acquired using an LMS Pimento frontend (24 bit resolution) and a laptop computer (Fig. 6).

Figure 6: A 2DOF- Sensor support (left) and the measurement center (right).

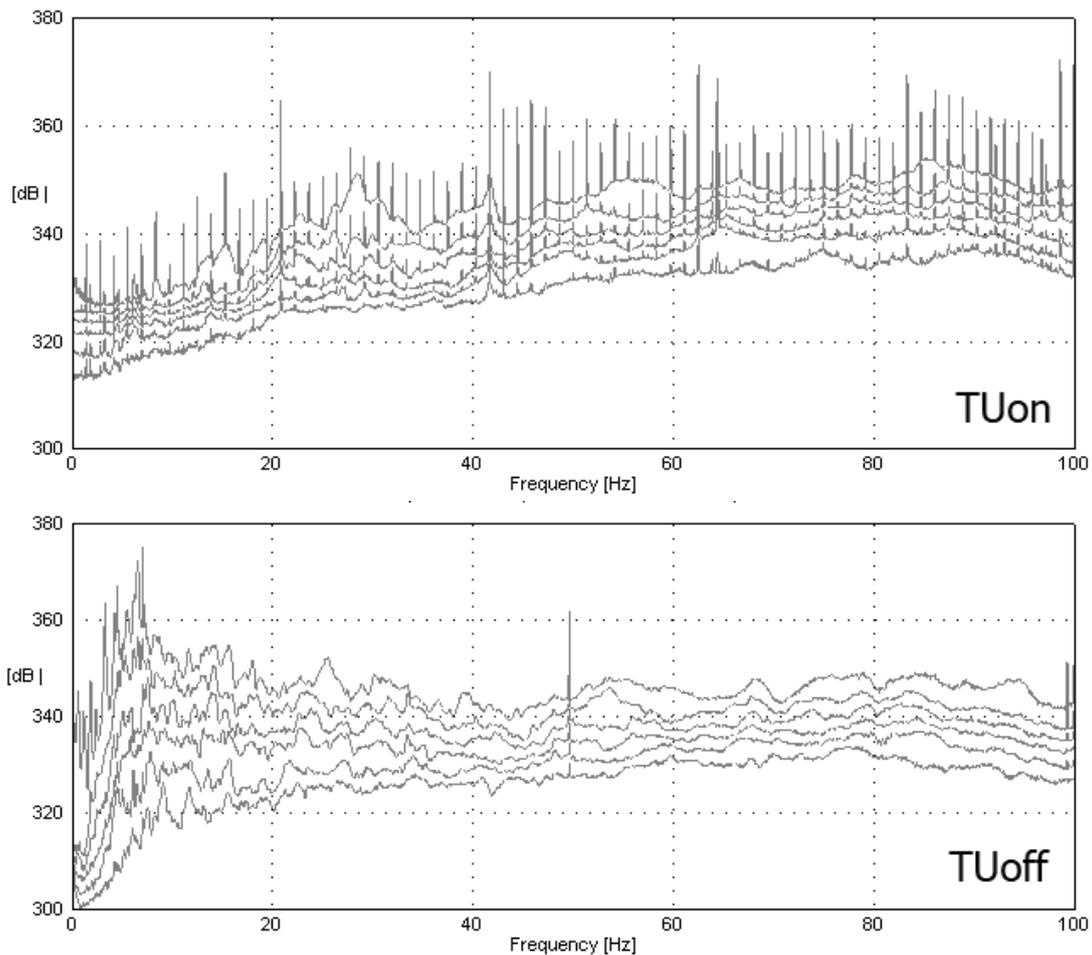
With the sampling rate $s = 200$ Hz, the Nyquist frequency lies at $f = 100$ Hz. The $0 \dots 100$ Hz SVD diagrams (Singular Value Decomposition) for both global tests are presented in Figure 7. It becomes clear that the structural response for TUon is dominated by the vibrations forced by the units rotating at $f = 1.39$ Hz (and including all harmonics) and that for TUoff, the main energy of the response is concentrated in the range below $f = 10$ Hz.

Figure 7 : SVD Diagram (Singular Value Decomposition) for all 11 setups for TUon and TUoff .

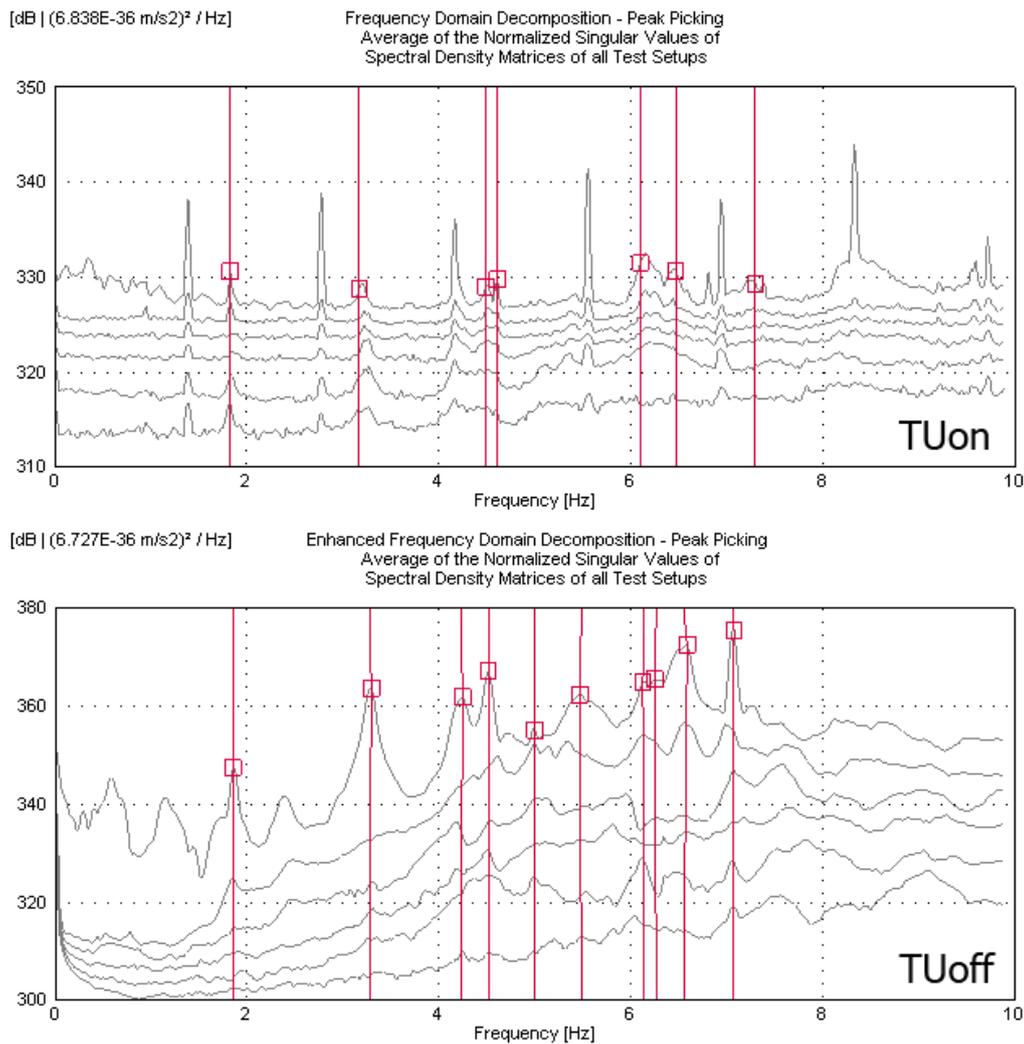
For the continuation of the discussion the $f = 0 \dots 10$ Hz range will be taken into consideration only. Figure 8 gives the same SVD diagrams as Figure 7 but for $f = 0 \dots 10$ Hz and with the picked modes indicated. For TUon it is easy to see that small signs of natural structural vibrations can be distinguished between the peaks representing the turbine's rotation. For TUoff almost all peaks represent physically meaningful modes. For some peaks, where no mode indicator line is given, damping estimation using EFDD was not possible. Damping estimation using EFDD requires manual estimation for all modes and all setups. Problems arise in cases where a mode exists in some of the setups but not in all of them.

Figure 8 : SVD (Singular Value Decomposition) for all 11 setups for TUon and TUoff.

The modes having been "identified" according to Figure 8 are summarized concerning frequency and damping (for TUoff) in Figure 9. This figure also gives the MAC value. The related mode shapes, as far as mode pairs could be established, are given in Figure 10.

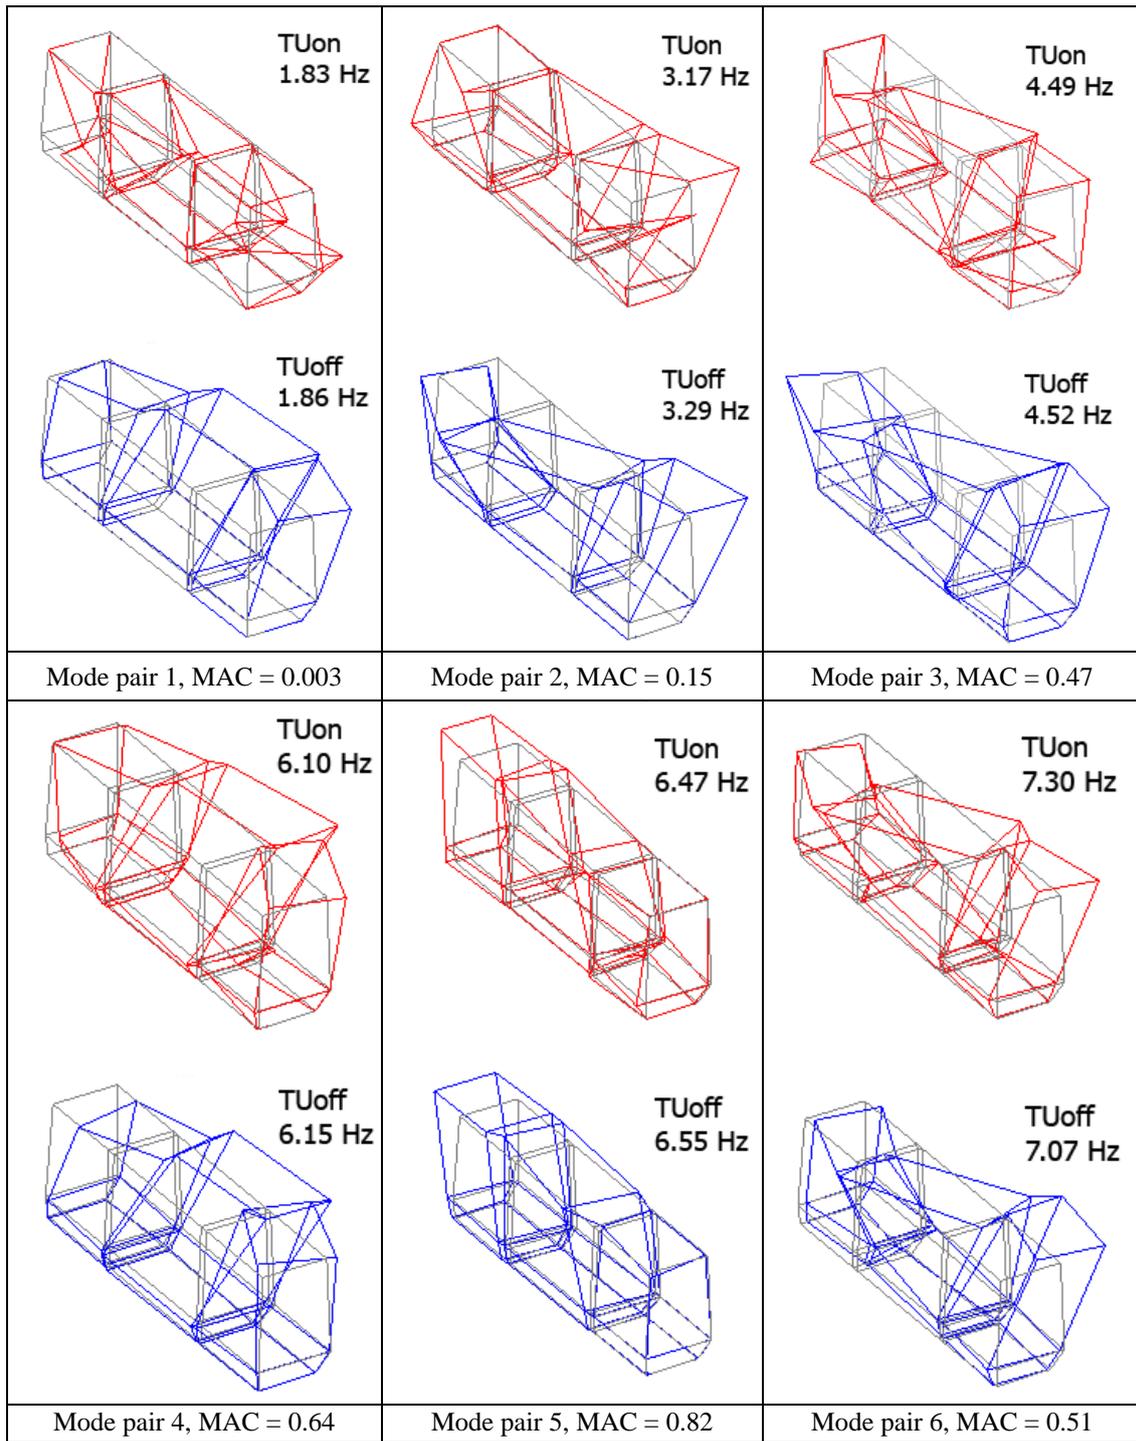
Figure 10: Mode shapes as determined for TUon and TUoff. Also indicated are the MAC values.

The MAC-value (Modal Assurance Criterion) gives a number between Zero and One for the degree of coincidence between two mode shapes. It is interesting to see that this value lies between 0.003 and 0.82 for the six mode pairs discussed here. What can not really be seen in Figure 10 is the fact that, in the cases of MAC being below $MAC = 0.45$, the mode shape is dominated by the rotational movement of the machine floor. This can however be seen when having a look at the animated mode shapes (if not available: please order at rci@rcidynamics.ch).

movement of the outer power house parts does not dominate in all cases. It is definitely destroying the shapes of the TUon modes related to mode pairs 1 and 2 (Fig. 9 and 10). From mode pair 3 on, the movement of the main structure is strong enough to cope with the machine floor rotation.
