Bridge Vibrations Excited Through Vibro-Compaction of Bituminous Deck Pavement

Reto Cantieni
rci dynamics, Structural Dynamics Consultants
Raubbuehlstr. 21B, CH-8600 Duebendorf, Switzerland

ABSTRACT

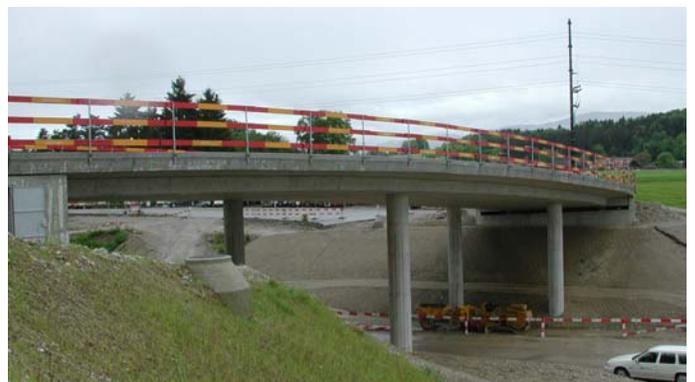
Figure 1. View of the bridge.

The tests were performed on a reinforced concrete highway bridge with spans of 17, 20 and 16 m. The cross section is a massive slab with a 0.9 m thickness and an overall (variable) width of roughly 14 m. The intermediate supports are two circular columns clamped at both ends, the abutments are basically horizontally free line bearings (Figs 1, 5, 6).

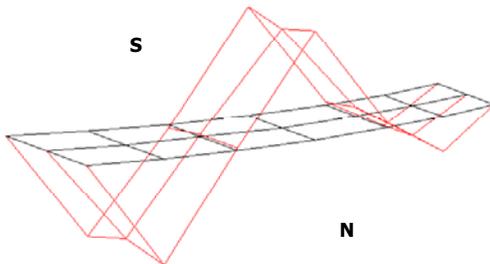
$f_1 = 5.00$ Hz

Figure 2. First natural mode of the bridge without pavement.

The natural bridge vibrations were identified using ambient vibration technology. Two highly sensitive accelerometers PCB 393B31, 10 V/g, a data conditioning and acquisition device OROS OR25, a laptop computer and the ARTeMIS software package were used. One of the accelerometers was placed in a fixed reference point whereas the other sensor was roved over the structure covering a total of 14 additional measurement points. The two abutment lines were not measured. 15 bridge natural modes with frequencies in the range $f = 5.00 \dots 134.0$ Hz could thus be identified. As examples, Figures 2 and 3 show the results for two of the modes identified.

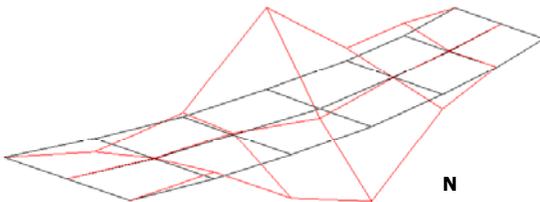
$f_8 = 39.75$ Hz

Figure 3. Bridge mode No. 8 for the bridge without pavement.

The frequencies of the modes No. 7 to 11 (27.0, 39.75, 56.6, 63.25 and 68.65 Hz) lie in the range of dynamic forces exerted by the rollers. The reason why this fact was found not be critical is described later.

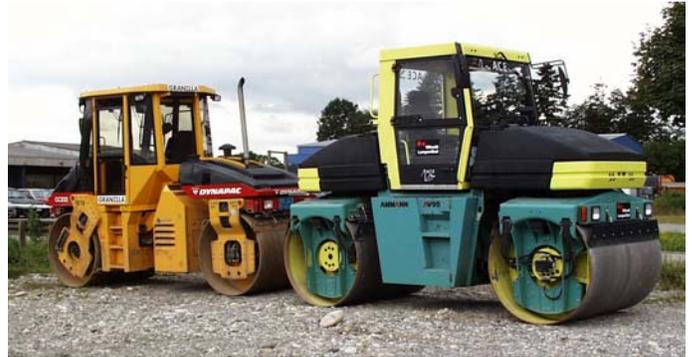
Figure 4. The rollers DY52/70 (left) and AV95 (right).

This roller has an operating mass of 9.5 t, a variable vibration frequency $f = 25 \dots 50$ Hz, a respective vibration amplitude $h = 0.62 \dots 0.1$ mm and a respective centrifugal force per drum $F = 52 \dots 7$ kN. (The vibration amplitude is related to the

drum's jump height when operated on a rigid surface). In this paper, the roller is designated as "AV95" (Fig. 4).

This roller has an operating mass of 8.0 t, a vibration frequency of either $f = 52$ Hz or $f = 70$ Hz, a respective vibration amplitude of 0.5 mm and 0.22 mm and a respective centrifugal force per drum of $F = 89$ kN and $F = 65$ kN. In this paper the roller is designated as "DY52" and "DY70" respectively. In case of the vibration frequency not being an asset, the designation used is "DY52/70" (Fig. 4).

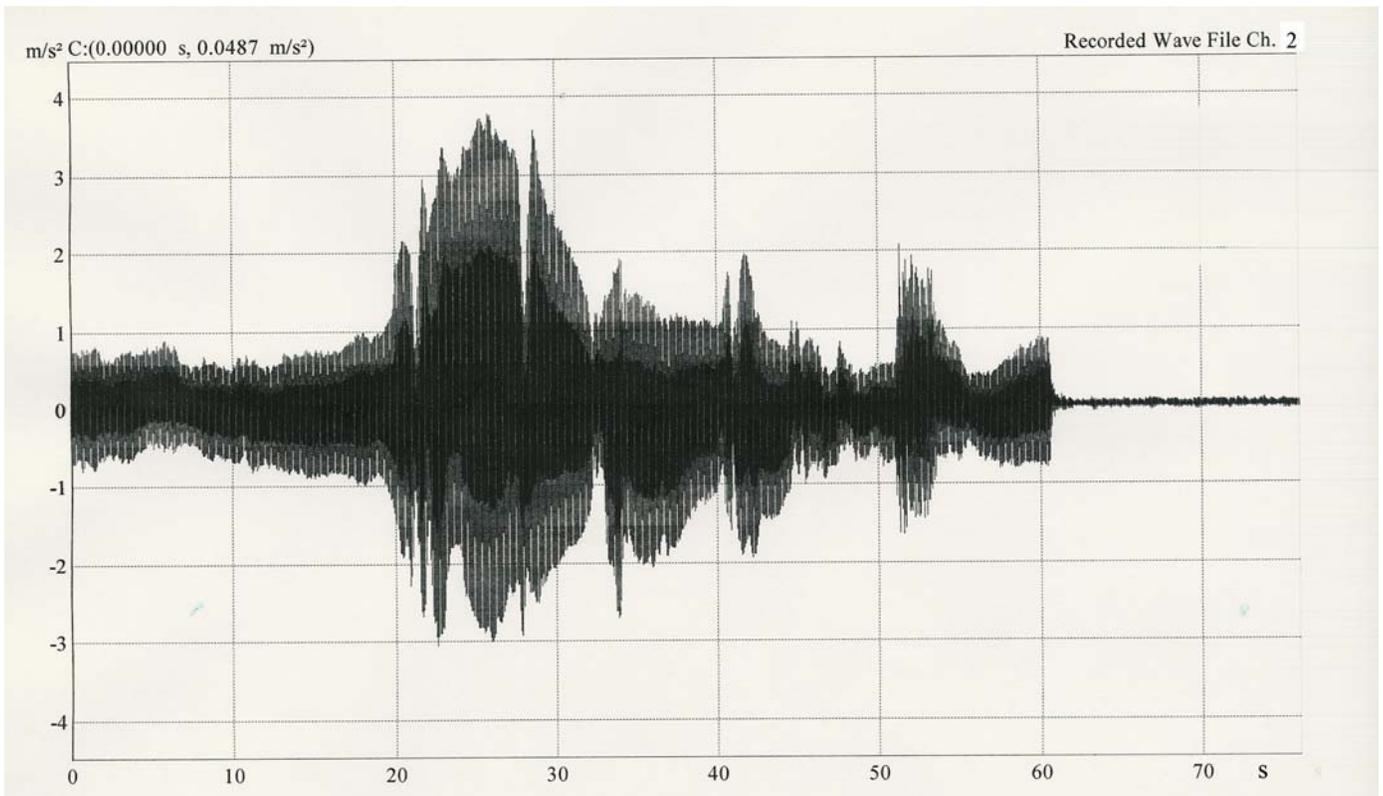
Figure 7. Acceleration time signal measured in point No.2 during compaction with roller AV95.

Figure 7 gives an acceleration time signal recorded in measurement point No. 2 (Fig. 6). The averaged, logarithmically scaled frequency spectrum calculated from the relevant part of this signal is shown in Figure 8. What can be seen from this spectrum?

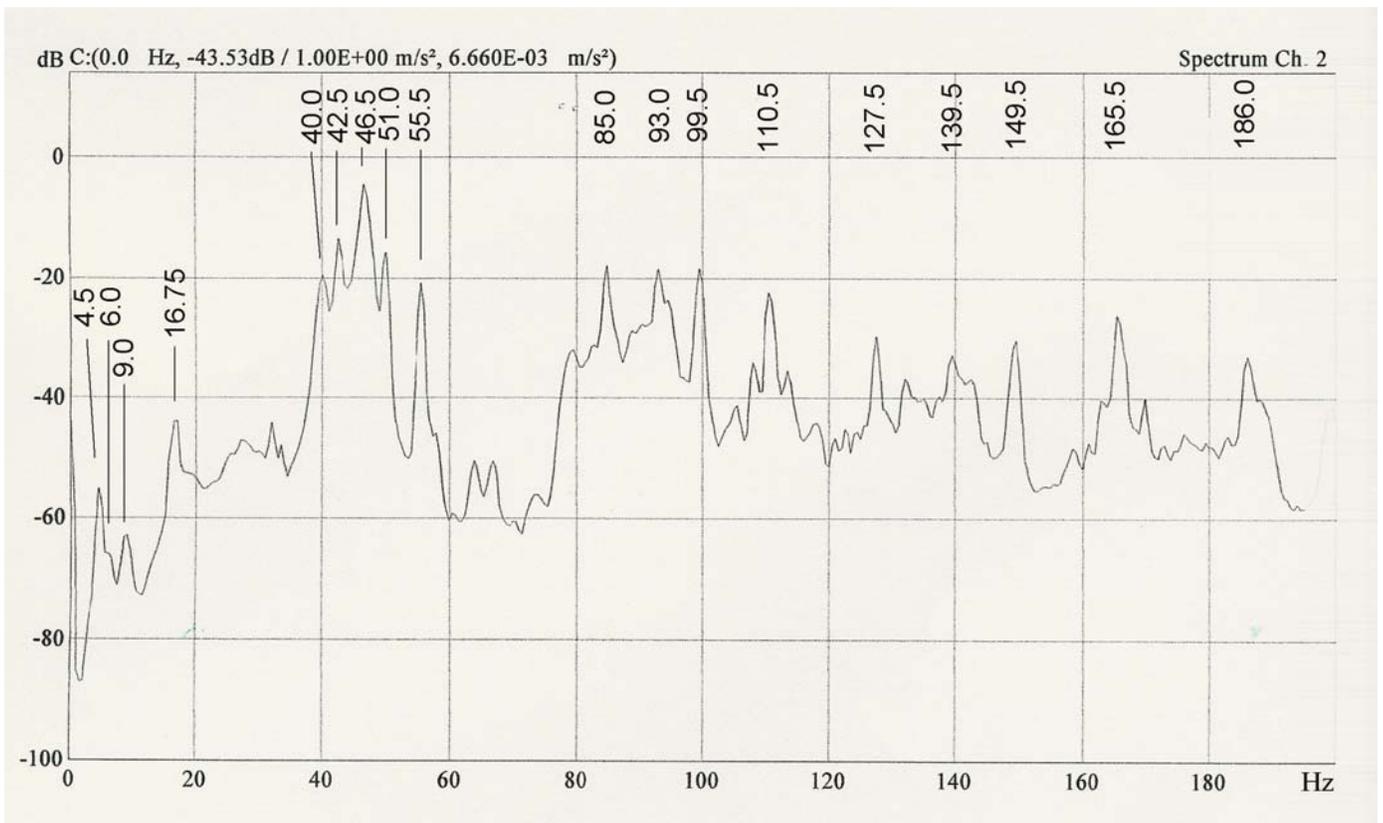
Figure 8. Frequency spectrum of the relevant part of the time signal shown in Figure 7.

a) Four bridge natural frequencies lying in the range $f = 4.5 \dots 16.75$ Hz can be distinguished. These frequencies are $\Delta f = 0.5 \dots 1.0$ Hz lower than those determined for the bridge without pavement. This indicates that, as a consequence of the continuously increasing mass of the pavement placed on the deck the bridge natural frequencies are subject to continuous decrease.

b) Vibrations induced by the roller are in the range $f = 40 \dots 51$ Hz plus the respective higher harmonics.

c) The vibration at $f = 55.5$ Hz was first thought to be related to the bridge mode No. 9, $f = 56.6$ Hz. However, due to the existence of the related higher harmonics this interpretation had to be abandoned. This vibration could later be related to forces generated by the roller's Diesel engine.

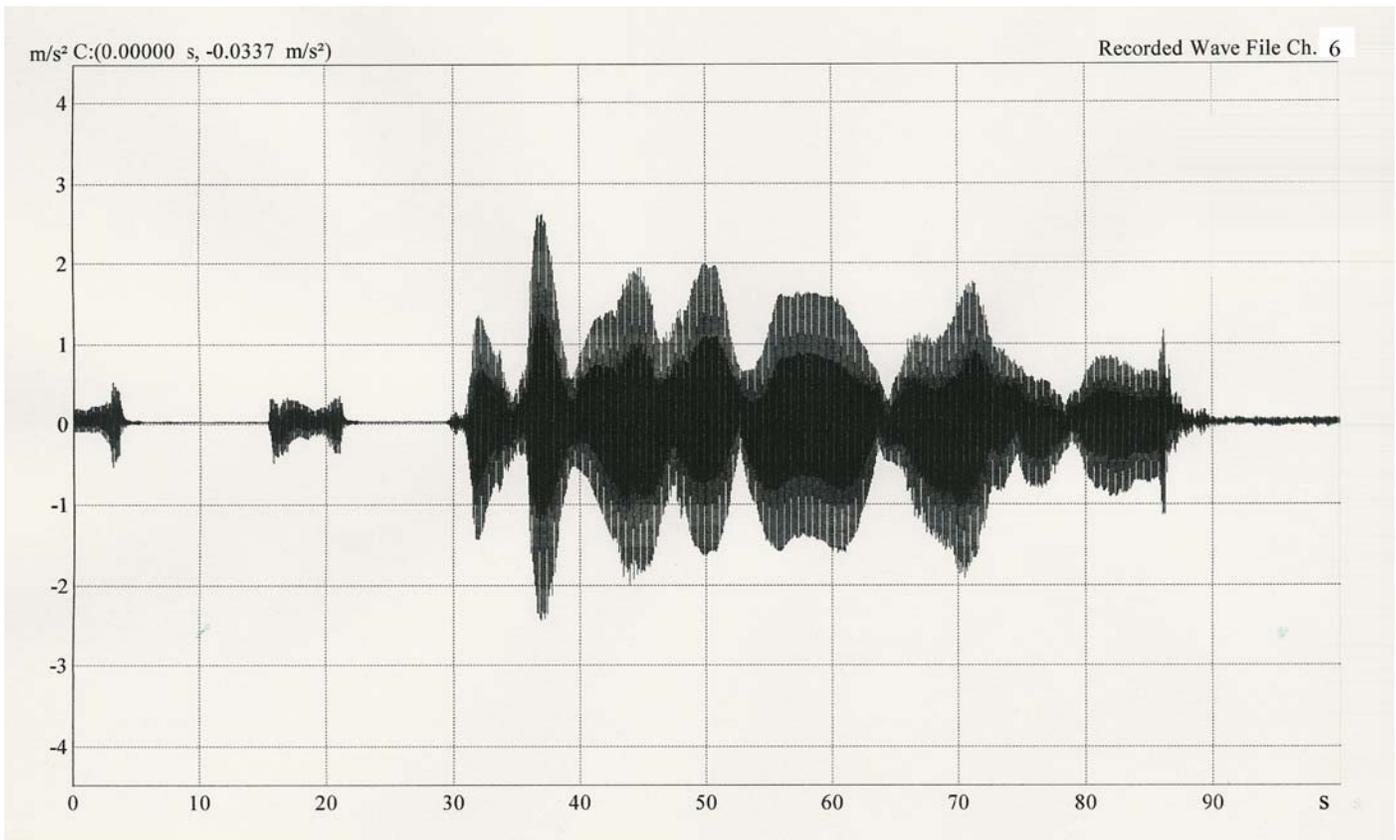
Figure 9. Acceleration time signal measured in point No. 6 during compaction with roller DY70.

Figure 9 gives an acceleration time signal recorded in measurement point No. 6. The averaged frequency spectrum calculated from the relevant part of this signal is shown in Figure 10. What can be seen from this spectrum?

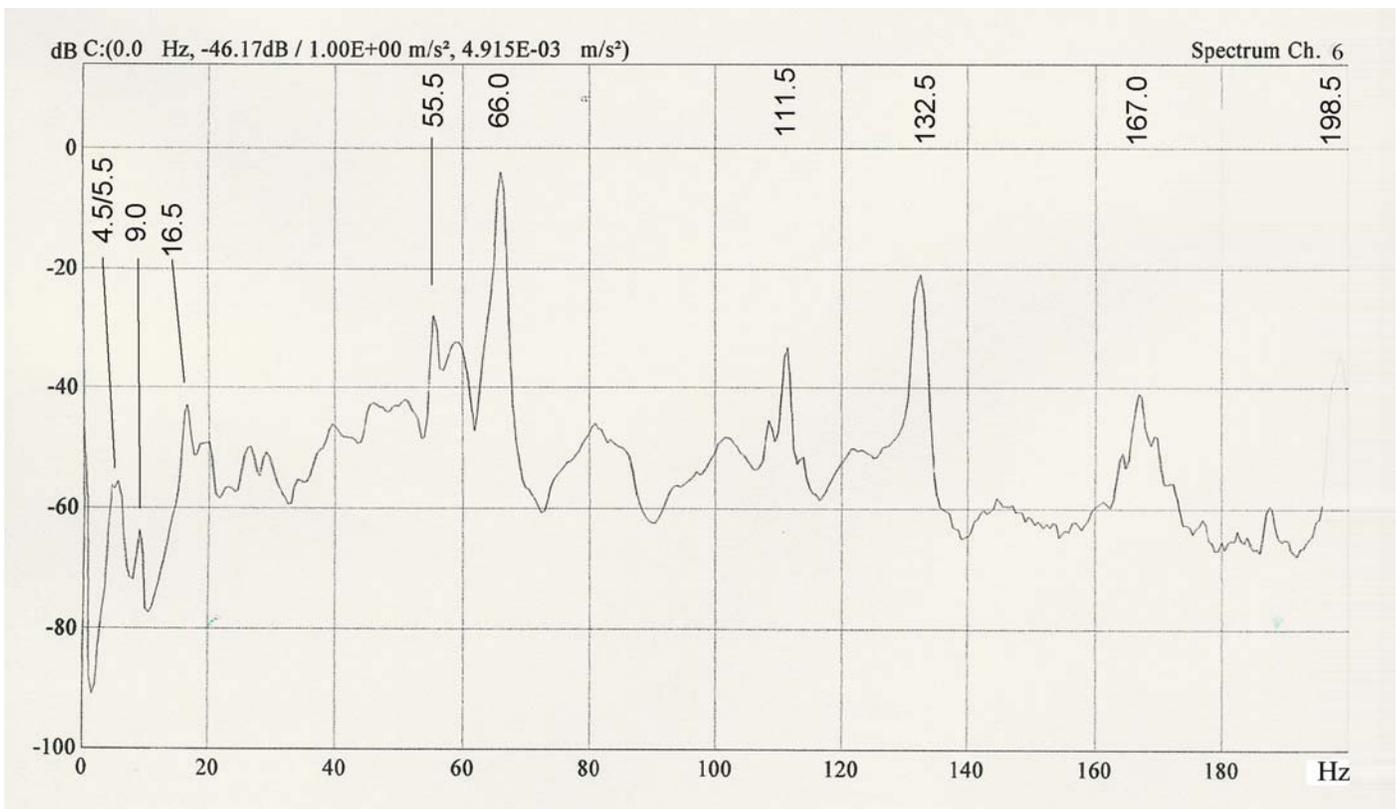
Figure 10. Frequency spectrum of the relevant part of the time signal shown in Figure 9.

a) Four bridge natural frequencies lying in the range $f = 4.5 \dots 16.5$ Hz can be distinguished. These frequencies are $\Delta f = 0.5 \dots 1.0$ Hz lower than those determined for the bridge without pavement.

b) Vibrations induced by the roller are $f = 66$ Hz plus the respective higher harmonics.

c) The Diesel engine induced vibration $f = 55.5$ Hz plus harmonics can also be identified.
